Don't Bet Your SBR!!

5 Year Inspection Shows 100% Solids Polyurethane Coatings Beat the Corrosion Odds

Table Mountain Casino & Bingo Located in the Foothills of the Sierra Mountains of California, twenty minutes from Fresno.

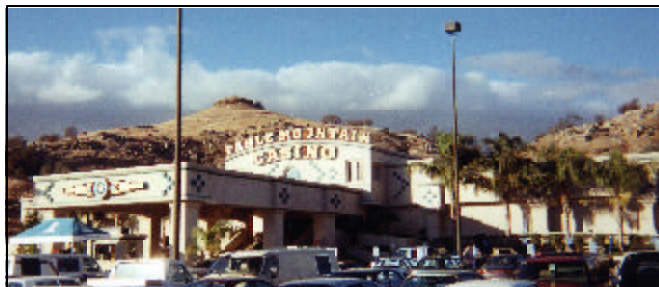
A recent inspection of the Table Mountain wastewater treatment plant corrosion protection system revealed that, after five years of service, the internal and external surfaces of the mild steel sequencing batch reactor (SBR) units are in excellent condition.

In 1999 the external coating of the Table Mountain SBR was inspected using a standard reference cell and voltmeter that measures tank-to-soil potential for each unit. The readings demonstrated that the external coating is in excellent condition.

The results of the internal inspection are equally compelling. Although the liquid level in the tanks could not be dropped completely, in the vapor phase areas where corrosion is usually the worst, there was no evidence of corrosion or coating breakdown whatsoever. In fact, the inspector noted that "the coating looked as bright and shiny as the day it was applied". The only imperfection was found along the rungs of a ladder where a large chain was used to drag a heavy submersible pump up and down. The weight and movement of the chain caused some minor chips in the coating, resulting in a trace of surface rusting.

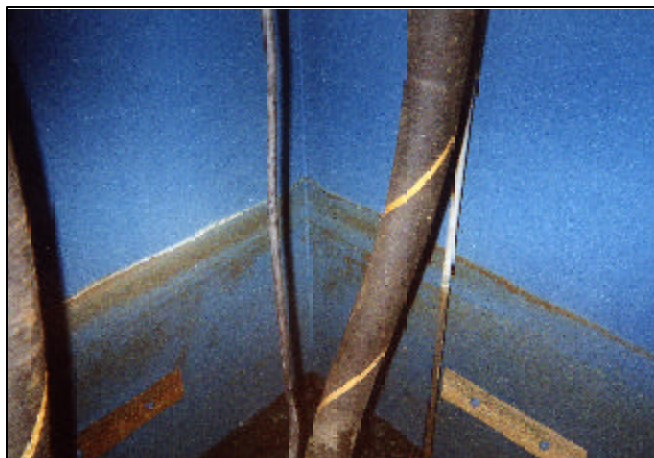
The Inside of the Table Mountain SBR coated with 16 mils (400 microns) of Madison's **Corrocote Plus**. No evidence of coating breakdown or corrosion whatsoever.
