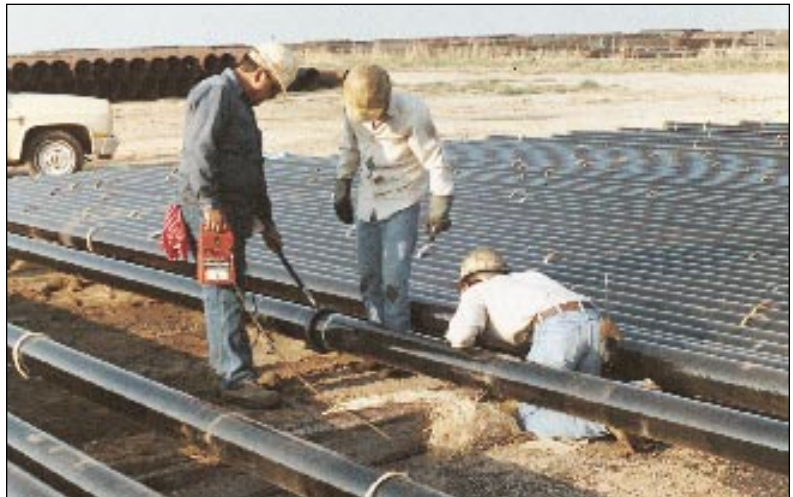
Fig. 4 - Holiday testing can be performed as soon as one hour after application of a 100% solids plural component polyurethane coating.

- Holiday detector test. Holiday detection should be carried out after or between coating applications (Fig. 4). The holiday test will find nicks, pinholes, and other film discontinuities. A low voltage holiday detector is often used. It consists of the detector, a ground cable, and a sponge electrode. High voltage holiday detectors are also being used for DFT above 10 mils (25 micrometers) on applications such as pipe lining and exterior coating projects.
