OIL & GAS JOURNAL

Shiwei William Guan
Madison Chemical Industries Inc.
Milton, Ont.

Zunyi Li
Huaiyi Liu
Yarning Chen
Guanglu Xie
Guozhou Zhang
PetroChina Tianjin Dagang Oilfield
China

Rigid-PU coating addresses chronic corrosion on northern Chinese gas pipeline

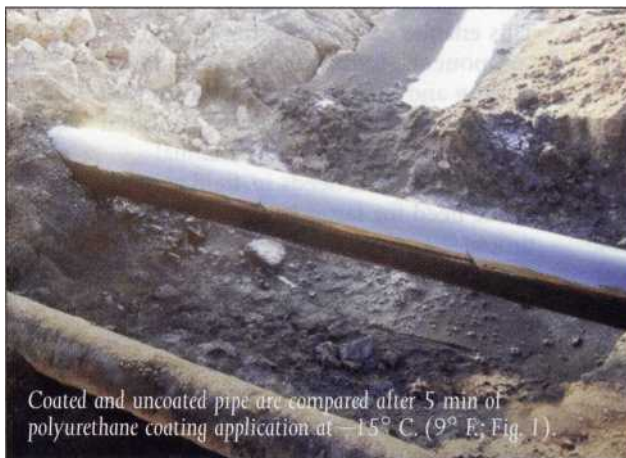
Coated and uncoated pipe are compared after 5 min of polyurethane coating application at -15°C (9°F; Fig. 1).

Hong-Yuan salt field, No. 3 Section Cloudy, application temperature: -15 C.
--- Surface preparation -----	----- Sa 2.5, angular profile: 40-60 m -----
Coating dry-to-touch time	1.5 min
Coating appearance	Smooth, glossy
DFT thickness	average 900-1,000 m based on 12 points
Adhesion testing (X cut)	Excellent, no disbondment difficult to cut
Holiday testing	Passed 12 kv holiday testing
