PIPELINE REHABILITATION AT ALL ENVIRONMENTAL TEMPERATURES WITH ADVANCED 100% SOLIDS STRUCTURAL AND RIGID POLYURETHANE COATINGS TECHNOLOGY

Dr. Shiwei William Guan, Madison Chemical Industries Inc., 490 McGeachie Drive, Milton, Ontario, Canada
Zunyi Li, Huanyi Liu, Yaming Chen, and Guanglu Xie, PetroChina Tianjin Dagang Oilfield, P.R. China

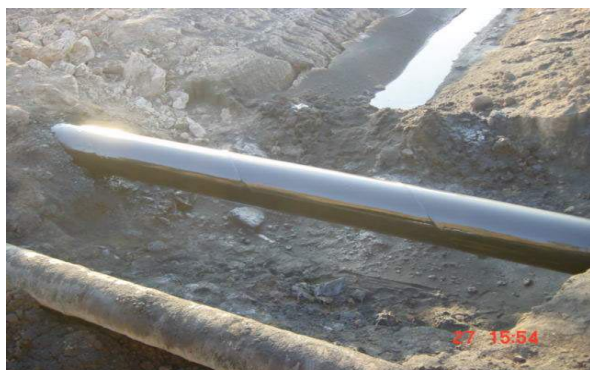
Figure 1. Comparison between a coated and uncoated pipe after 5 minutes of the polyurethane coating application at -15°C (9°F)

One of the main pipelines that supply natural gas to northeastern Chinese cities, the 100 km x 21-inch (529 mm) diameter DaGang-CangZhou gas pipeline was installed in 1973, originally protected by a petroleum asphalt enamel coating. Since then the pipeline has faced severe corrosion problems, which were not resolved even after numerous localized rehabilitation applications. In 2001, PetroChina Dagang Oilfield Natural Gas Company decided to completely refurbish the pipeline. A 100% solids, rigid and structural aromatic polyurethane coating technology, was selected for a river crossing and some underground/aboveground portions. For the river crossing and aboveground pipe segments, a thin film (3-5 mils or 75-125 microns) of a 1:4 mixing ratio, high solids, aliphatic polyurethane, was applied to coat over the 100% solids aromatic polyurethane coating for protection against ultra-violet (UV) light. The total application coating film thickness ranged from 35 to 40 mils (850 to 1000 microns). The application of the Madison's advanced polyurethanes was conducted between November 2001 and May 2002, with field application temperature ranging from 5°F to 86°F (-15°C to 30°C). Extensive tests on lab and field samples were then conducted. In November 2001, PetroChina Dagang Oilfield formed a special technical committee and officially appraised the rehabilitation project based on both testing results and field performance (Figure 1, 2, and 3).

The field inspection included two elements: in-situ adhesion and holiday inspection and field sample preparation for third-party lab testing. At -15°C, the field-applied coating cured in about 5 minutes. Adhesion and holiday testing were then conducted within 60 minutes of the coating application. It was found that at that time, the coating breakdown testing voltage already reached 12 kV (more than 342 volts per mil). The field-coated samples were packed and sealed on-site, and then were sent out immediately to the Pipeline Coating Testing Centre of the Research Institute of Engineering Technology of China National Petroleum Corporation.

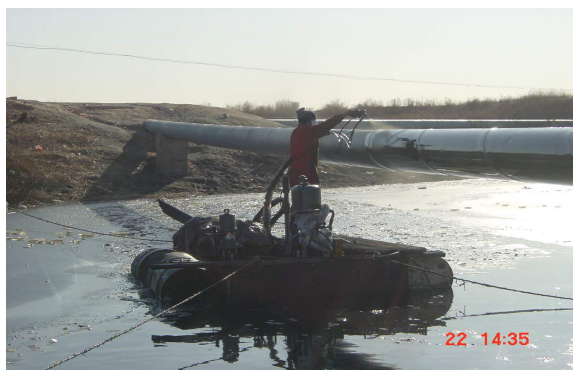
Figure 2. Application of the 100% solids, rigid, aromatic polyurethane coating for river crossing on top of an iced river

Prior to the coating application, the pipe section to be coated was surface cleaned to remove contaminations such as oil and dirt, and then abrasive blasted, using medium grade coal slag abrasives, to a near-white metal blasting (SSPC-SP 10 / Sa 2.5) with a surface profile of 40-60 microns. Coating application was done within 4 hours of blasting.

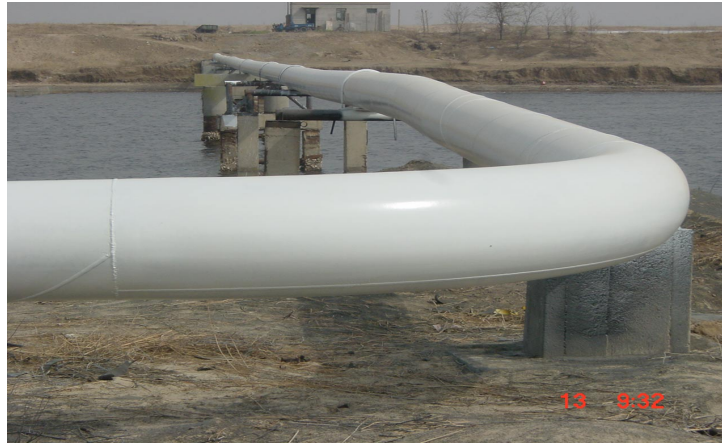
Figure 3. A river-crossing section of the DaGang-CangZhou gas pipeline after being re-coated with a 100% solids, rigid, aromatic polyurethane coating and then top coated with a high solids, UV stable, aliphatic polyurethane coating
