Not a Walk in the Park

1995 Inspection of sewer line at Rubes Creek Pump Station showed the perfect condition of Madison's coatings.

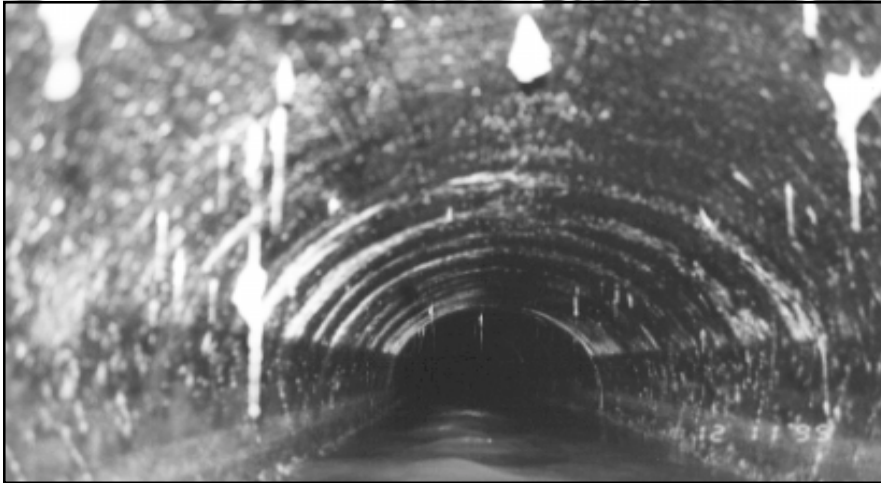
In addition, the low flow rate meant the sewer pipes were less than half full much of the time. Therefore, the flow could never wash away the acid or the acid producing bacteria. Finally, the line took input from some nearby industries and therefore regularly saw elevated effluent temperatures. All of these conditions created a very tough environment that would be expected to limit a coating's service life. The pipe was inspected almost 6 years after the initial installation. The internal coating was found to be in excellent condition without damaged or deteriorated areas.
