# I Can't See the Difference...Can You See the Difference?

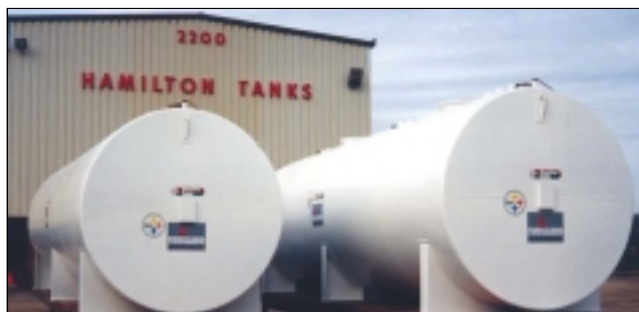
*AcrylaThane coated Fireguard tanks waited to be installed in the City of Vandalia, OH*

Compare photos of these tanks before installation with photos taken after six years of service. You almost can't tell the difference.

manufactured and coated by Hamilton Welding of Columbus, Ohio in 1994.

Surface preparation consisted of a standard commercial blast and the coating was applied in a single coat using conventional airless spray equipment—no primer. Four hours later, the AcrylaThane coating had cured hard enough to load the tanks on to a truck and ship them down the road.

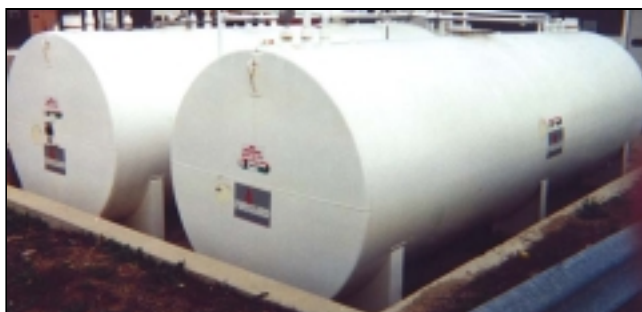
*AcrylaThane Coated Fireguard tanks after six years in service storing fuel for the City of Vandalia*

Two of the first tanks ever coated with Madison's AcrylaThane aliphatic polyurethane coating were installed at the municipal garage in Vandalia, OH, about 50 miles southwest of Columbus. At the time, the tanks looked bright white and brand spanking new. After six years of service storing fuel for the city's municipal vehicles, the twin 10,000 gallon steel Fireguard tanks are still in excellent condition — they look almost as good as the day they were delivered.

As expected, there is some minor corrosion around the lifting lugs

where the coating was damaged during installation and on one of the saddles where the coating was applied at a much lower thickness than recommended. Otherwise, the AcrylaThane coating is in great shape and there are no strap marks or other signs of handling damage.

Even where one of the support saddles is repeatedly immersed in rain water due to an uneven concrete pad, there are no signs of corrosion. The interior surface of the spill containment area, where there is a thick layer of gasoline and sludge, shows absolutely no coating degradation. Everything is still in tip top shape.
